Manhole Inspection Summary

Manhole # S15C__015MH

Insp Date: **3/13/08 10:50 AM**

Location Address: **2610 FRANKLIN ST**

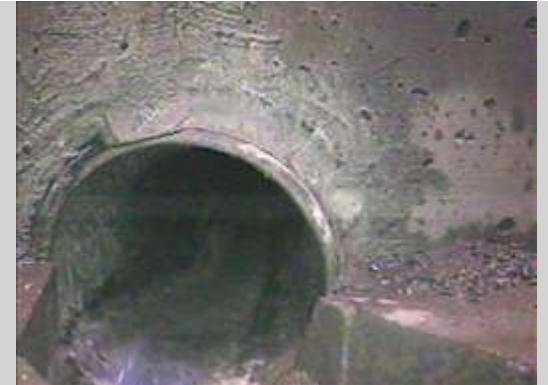
12 O'Clock Outflow

8 in. Circular Gravity Sewer
Pipe Out @ 12 O'Clock

Pipe Material: **Clay** ☐ Pipe Lined

Invert Depth: **6.99** (ft.) Flow Characteristics: **Slow**

Deposits: ☒ None ☐ Mud ☐ Sludge ☐ Debris ☐ Grease

Infiltration: **None** Pipe Seal Cond: **Sound**

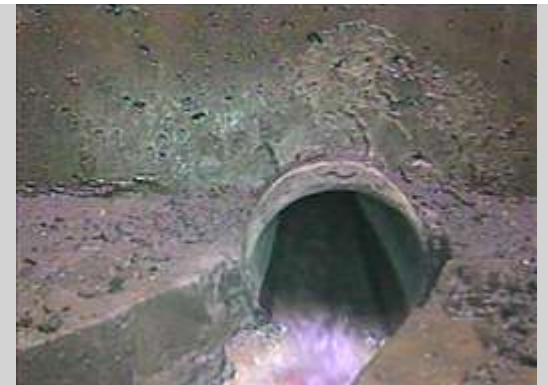
4 O'Clock Inflow

6 in. Circular Gravity Sewer
Pipe In @ 4 O'Clock

Pipe Material: **Clay** ☐ Pipe Lined

Invert Depth: **6.82** (ft.) Flow Characteristics: **Slow**

Deposits: ☒ None ☐ Mud ☐ Sludge ☐ Debris ☐ Grease

Infiltration: **None** Pipe Seal Cond: **Sound**
